### PORT MACQUARIE MUSEUM – STORE BUILDING 22 CLARENCE STREET, PORT MACQUARIE

### CONSERVATION MANAGEMENT STRATEGY

2 April 2025

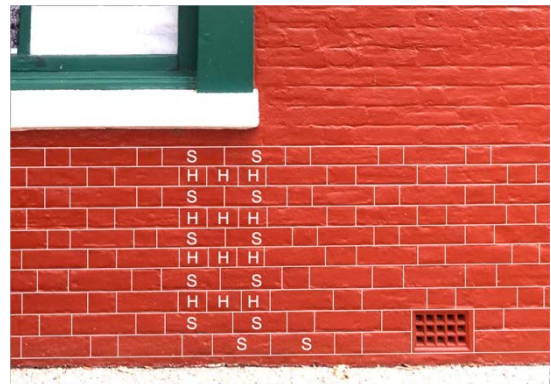
Fig. 18: Annotated photo of northern façade showing junction between Phase 1 and Phase 2 sections, where Flemish bond pattern is inconsistent (2 adjacent stretchers and 3 adjacent headers, instead of alternating in each course).

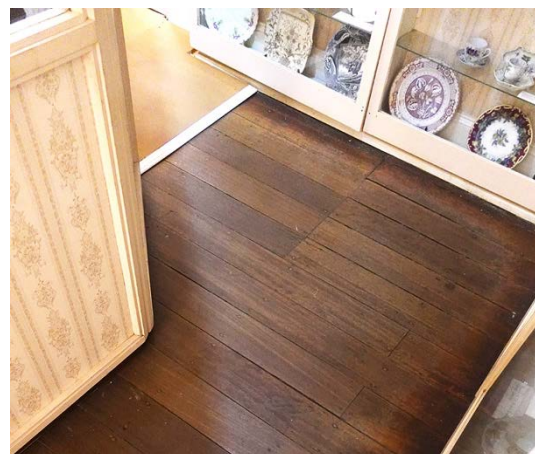
Fig. 21: Evidence of former stair location in first floor. (Source: Design 5, 2024).

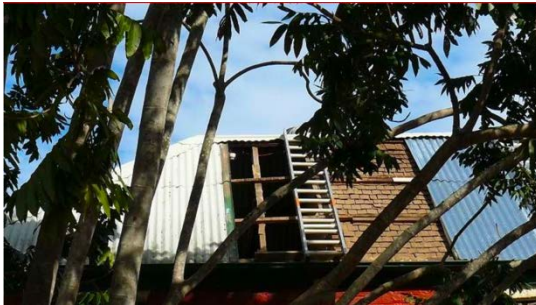
<p>Fig. 49: Timber shingles retained below corrugated sheet roofing. (Source: 2018 CMP, Inventory Sheet – Roofing, p31).</p>

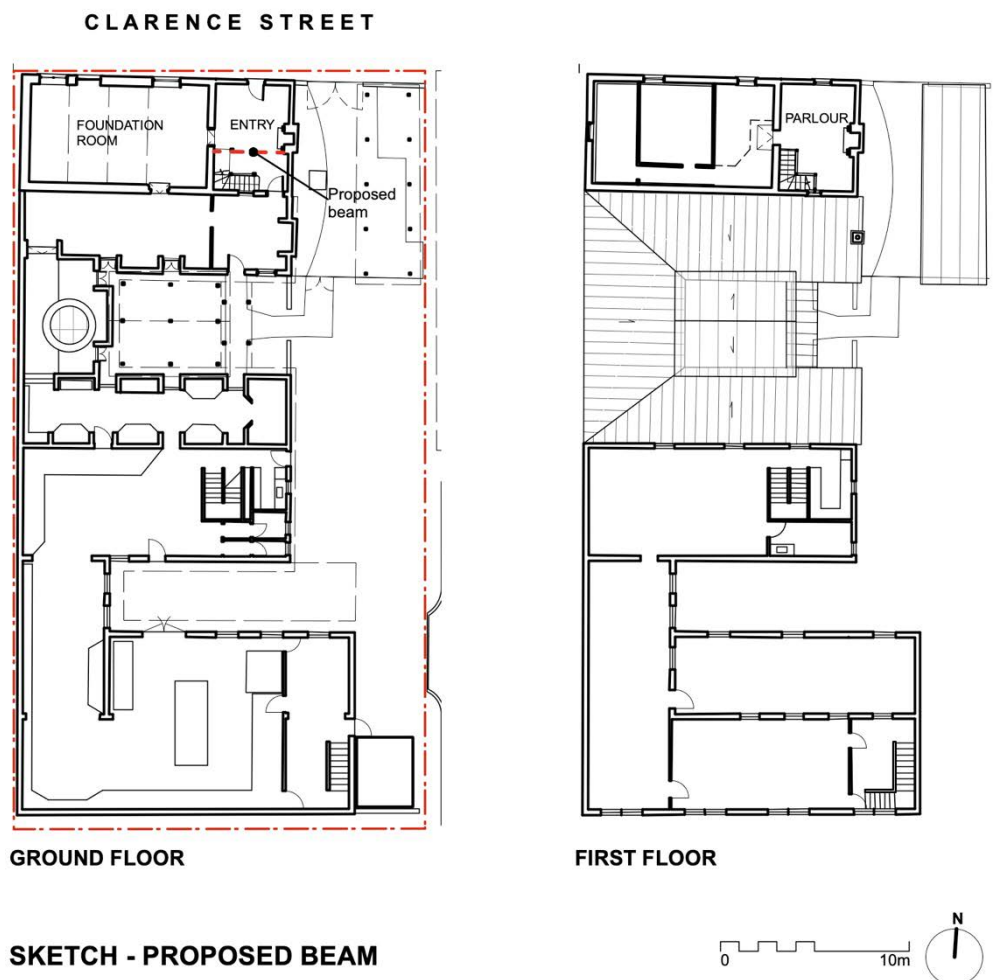
Fig. 61: Sketch showing proposed location of beam.

- Provide design and documentation for strengthening of first floor structure, including coordination of details with architect.
- Allow for one site inspection with the architect prior to design/documentation, and for site inspections during construction as typically required to obtain Occupation Certificate.
- Review and update Dilapidation Survey and Structural Report prepared by Dale Carr dated 2019 to inform future works.

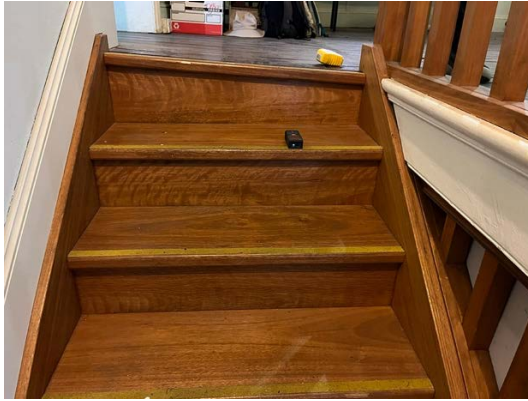
Fig. 64: Existing stair rising up to first floor Parlour, noting deflection in floor level. (Source: Design 5, 2024).

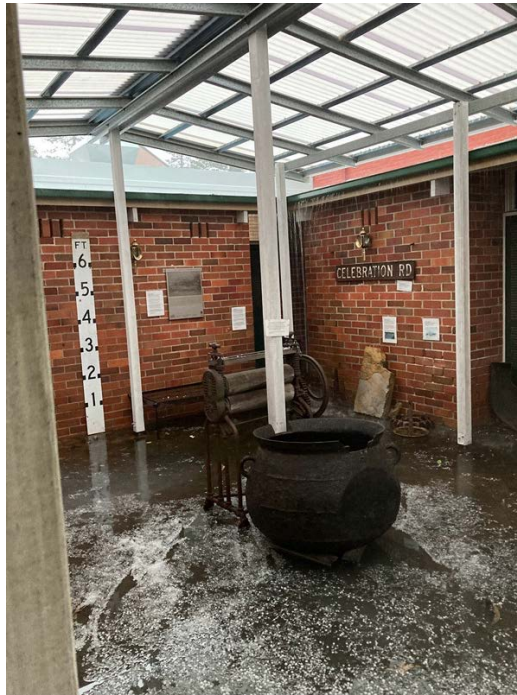
Fig. 65: North Courtyard flooded after hail storm in April 2024. (Source: Port Macquarie Museum).
