Port Macquarie Museum Maritime Collection Preservation Needs Assessment

Report prepared by
Julie McCarthy, Conservator (PMAICCM)

June 2021

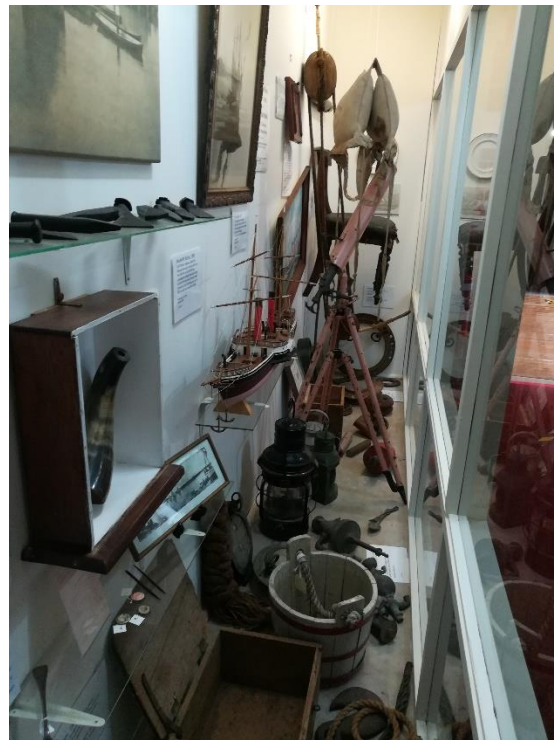
Image 2: Maritime Display case interior view

Ideally, the exhibition case would act as an environmental buffer for the objects, however, the cabinet is not acting sufficiently robustly to moderate the changes in RH. Regular monitoring of displayed collection items, particularly metals, textiles and photographic material is recommended.

The Maritime Collection has a single fluorescent tube lighting within the cabinet and has some indirect light from the heavy wooden rail doors that open directly onto the southern courtyard. Spot measurements taken inside the cabinet can be found [here](#). There are no window coverings over the sash windows in the Southern Gallery, however, they face the enclosed southern courtyard, which has had a transparent annex roof added, and there is little direct sunlight in this corner of the gallery space.

- It is recommended that the museum seek funding to obtain new display case/s, one where environmental conditions can be maintained, LED lights can be installed within the display case, and where changeovers can be undertaken with minimal risk to volunteers.
- In the interim, self-indicating silica gel could be placed in the display case to help reduce humidity levels.
- All framed works have original mounts replaced with rag board (unbuffered for photographic works) – note individual object recommendations can be found in [Appendix 5](#).
- Conservation work should be undertaken to conserve the cabin chair from Ben Boyd's schooner.
- A metal conservator should assess the metal exhibition items upon removal from current display

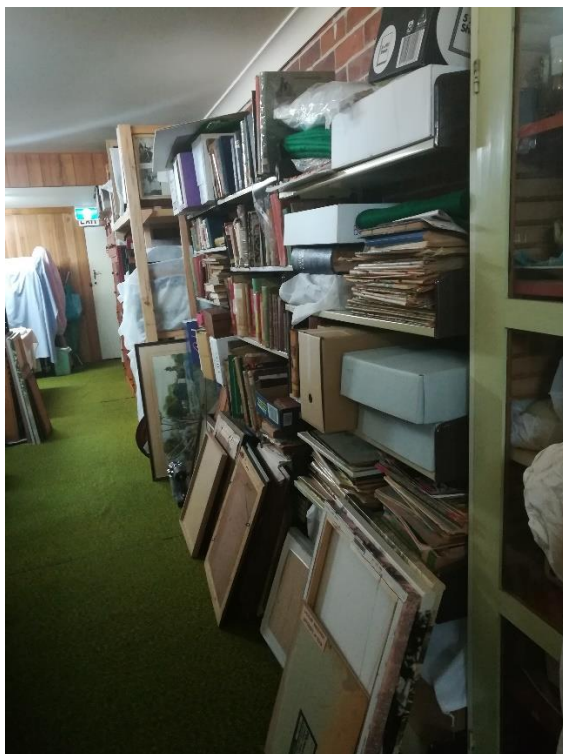
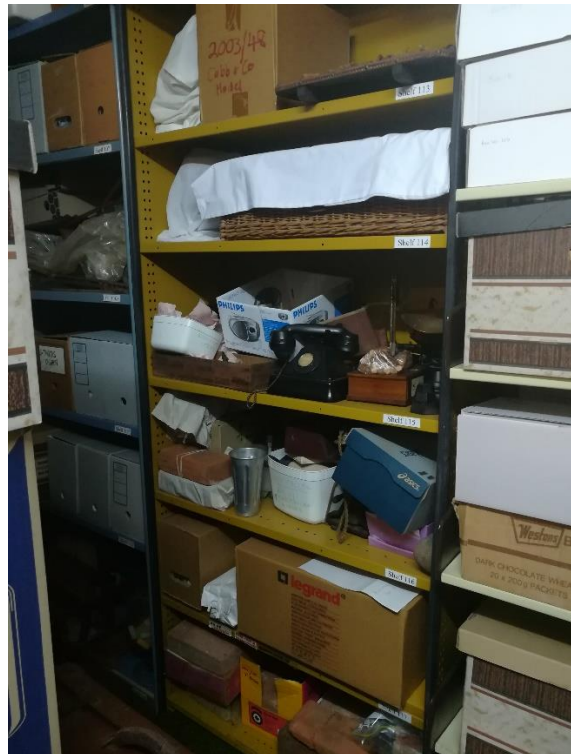
Images 7 & 8 Museum Storage area

There is currently about 170 metres of metal shelving in the main storage room, and an additional 55 metres of shelving for rehoused textiles and works on paper in the upstairs workroom. However, there is insufficient storage for the size of the collection. The museum storage is very overcrowded. The space between some bays is less than 50cm wide, which is much too narrow - less than 70cm is not recommended and 90cm is recommended (see [Image 10](#)). There are also collection items on the floor in between shelving and there are boxes stacked up against some walls (See [Image 7-9](#)).

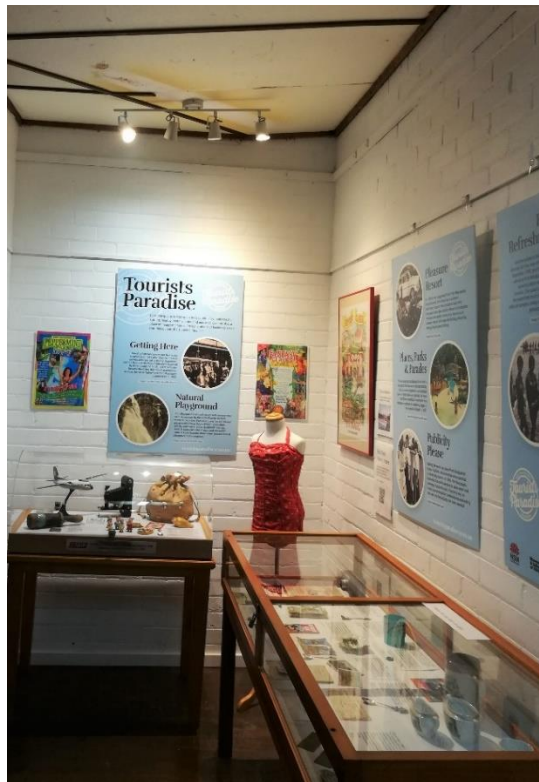
Image 12: Display in the Arcade of Shops

The additions are also constructed of brick and have cement and wooden floors that are carpeted. The extension from 1968 appears to have polystyrene ceilings which has been damaged by lighting and water in the past (see [Image 12](#)). There are wooden and glass sash windows and wooden doors throughout. The archive and administrative areas are air-conditioned.

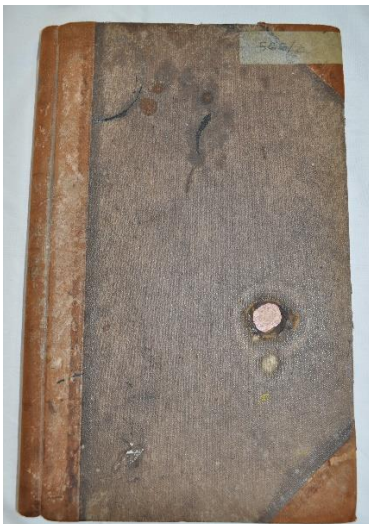
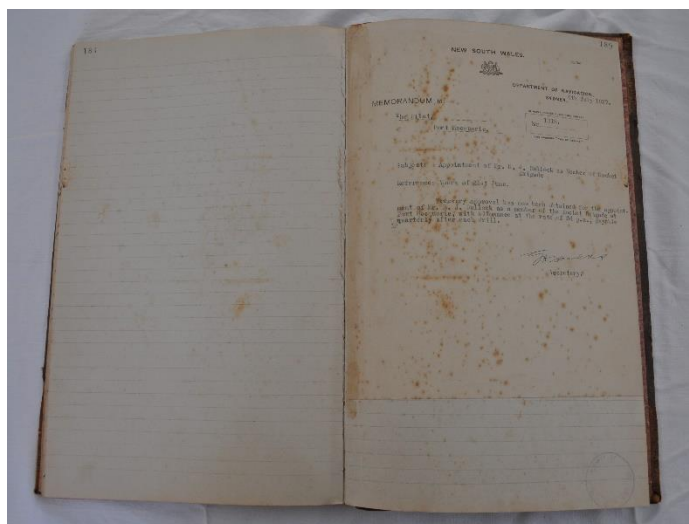
Images

There is a large burn hole in front cover which highlights marbled endpapers beneath. Masking tape with accession number on the top right of the cover. Oil stains and other marks (including from an ink well) on the front and back covers.

Should the museum wish to display it later, it is recommended that a book cradle be made for it to safely rest upon.

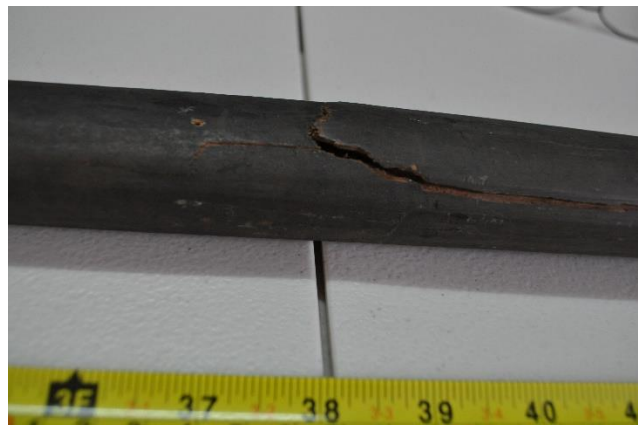
Currently the oars have no specific housing and are kept upright in the main storage area, where they are in danger of further damage. Currently the graphite inscription on 2090b is covered in a PE cover tied with white string.

2090a – oar loom showing significant splitting

- Consolidate the split in the handle of 2090b
- Create a custom Perspex storage box that can double as a display case to ensure that the graphite is not handled and that the oars stay well supported.
- Ensure when stored the graphite inscription is face up in the case.

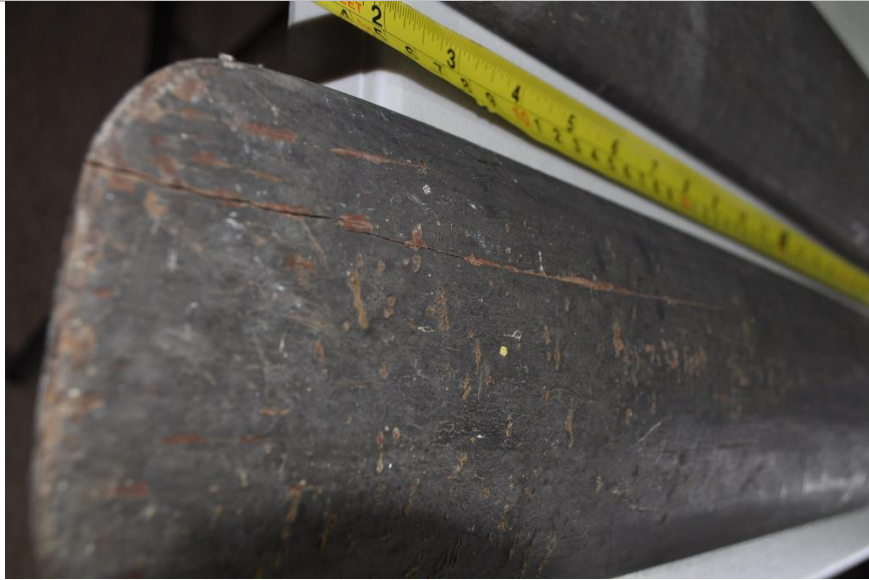
Oar 2090a showing splitting along the blade

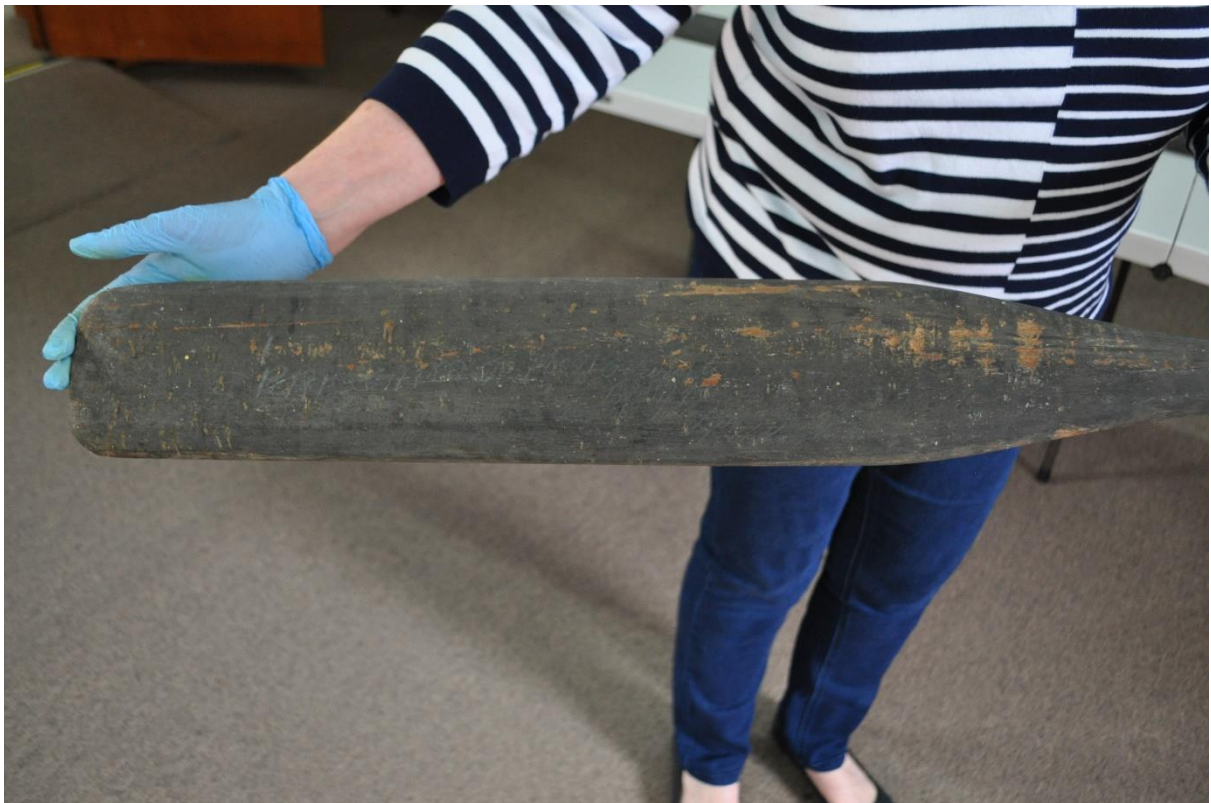
Oar 2090b – with graphite annotation and showing paint loss

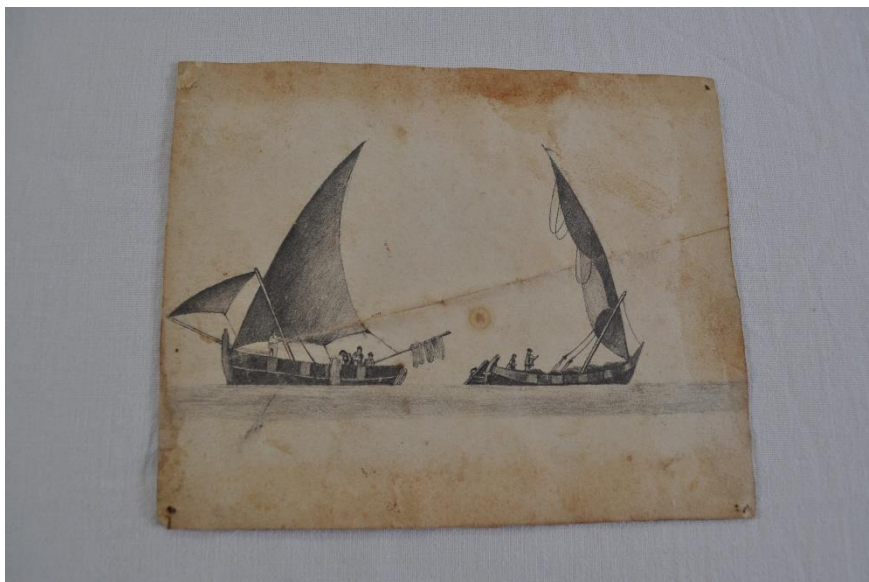
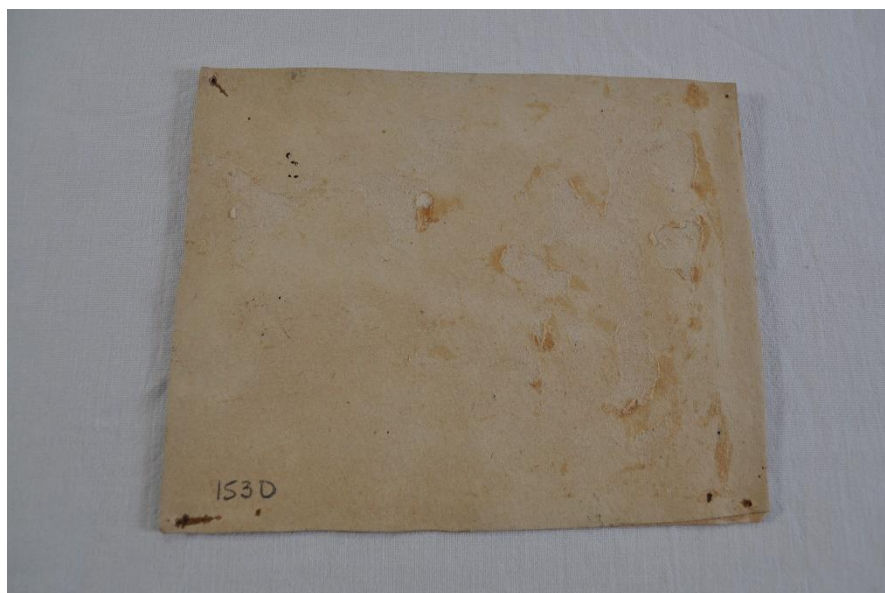
Images - recto

Significant surface dirt. It has been previously backed to the secondary support to repair or reinforce the heavy central crease. However, this has now buckled and cockled, and dirt has gathered in the crease making it visually disturbing. Small but obvious tidemark in central image area. Perforations from four pin holes. Adhesive residue on the bow of the boat on the left.

- Dry surface clean off image area. Backing removal. Blotter wash and localised reduction of tide-marked stain.
- Reduce central crease and repair tear at the end of it (RE). Humidify and flatten.
- Rehouse in exhibition-ready mount.

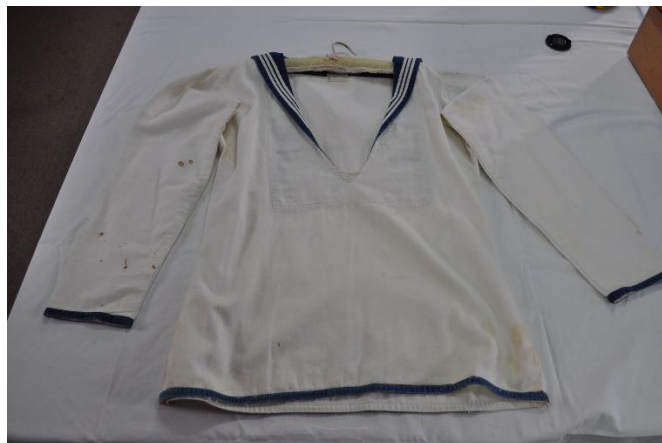
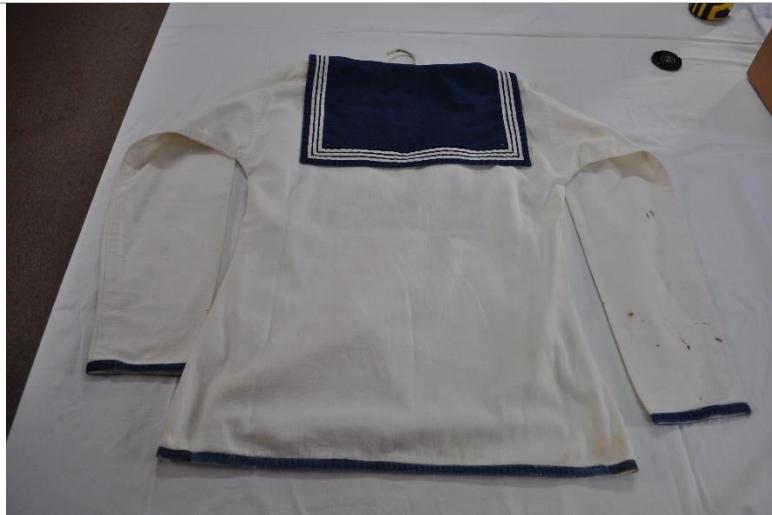
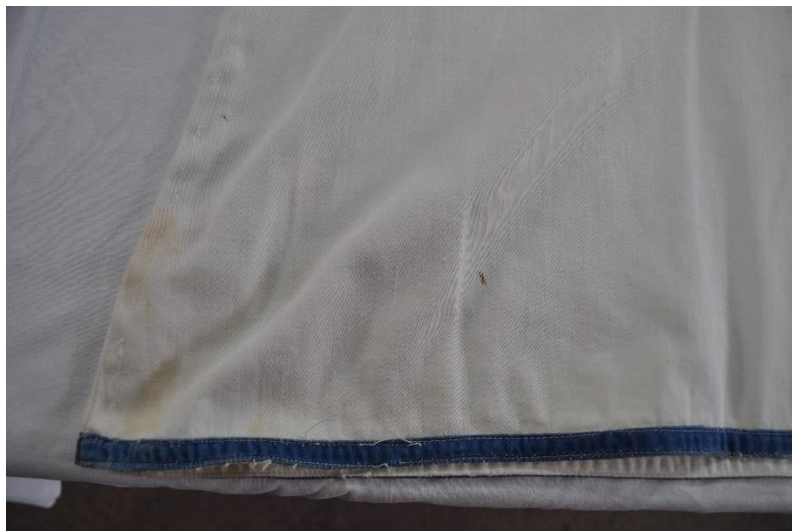
Images

There are a number of stains on the sleeves, some look to be rust-stains, particularly on the sleeves. The shirt has some soil and surface dirt.

The stitching is in varying condition. Previous repair on right sleeve has come unstitched.

There is a pink stain under the blue collar at the back

- Conservation wash to reduce soil and staining
- Rehouse in corrugated blue board textile box, interleaved with tissue

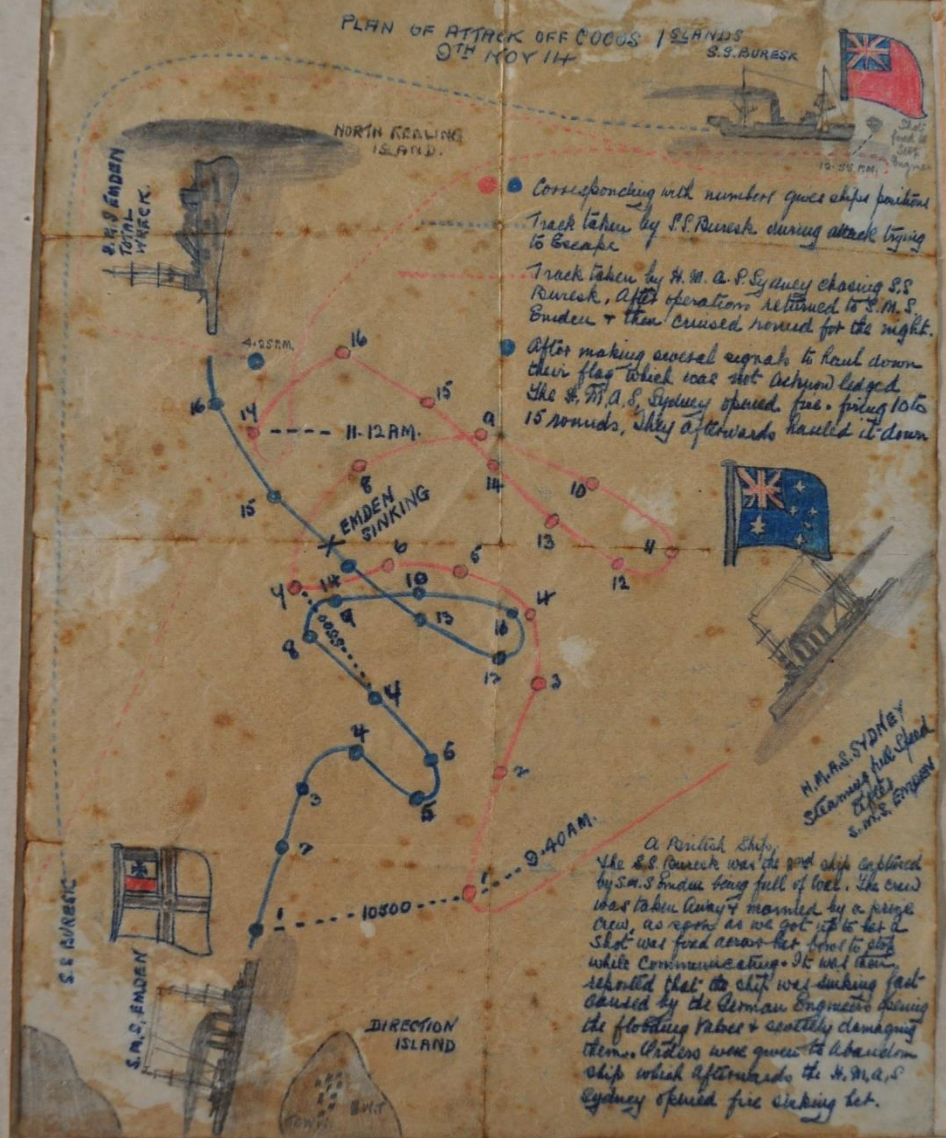
Image - recto

The plan was stored for some time folded as the paper has significant creasing and tears along these fold lines. Scattered foxing throughout plan area. Significant discolouration and staining throughout image substrate.

- Dry surface clean, remove from secondary support. Wash to remove deterioration product and reduce staining. Strip repairs using Japanese tissue and wheat starch paste.
- Rehouse the plan in an exhibition ready archival mount. Store flat in a solander box.
